Subaru Service Bulletin #16-136-22R

APPLICABILITY: 2019-22MY Ascent
2020-22MY Legacy & Outback 2.4L Turbo

SUBJECT: Vibration & Possible Judder Concern on Turns
Under Acceleration

NUMBER: 16-136-22R
DATE: 01/20/22
REVISED: 04/26/22

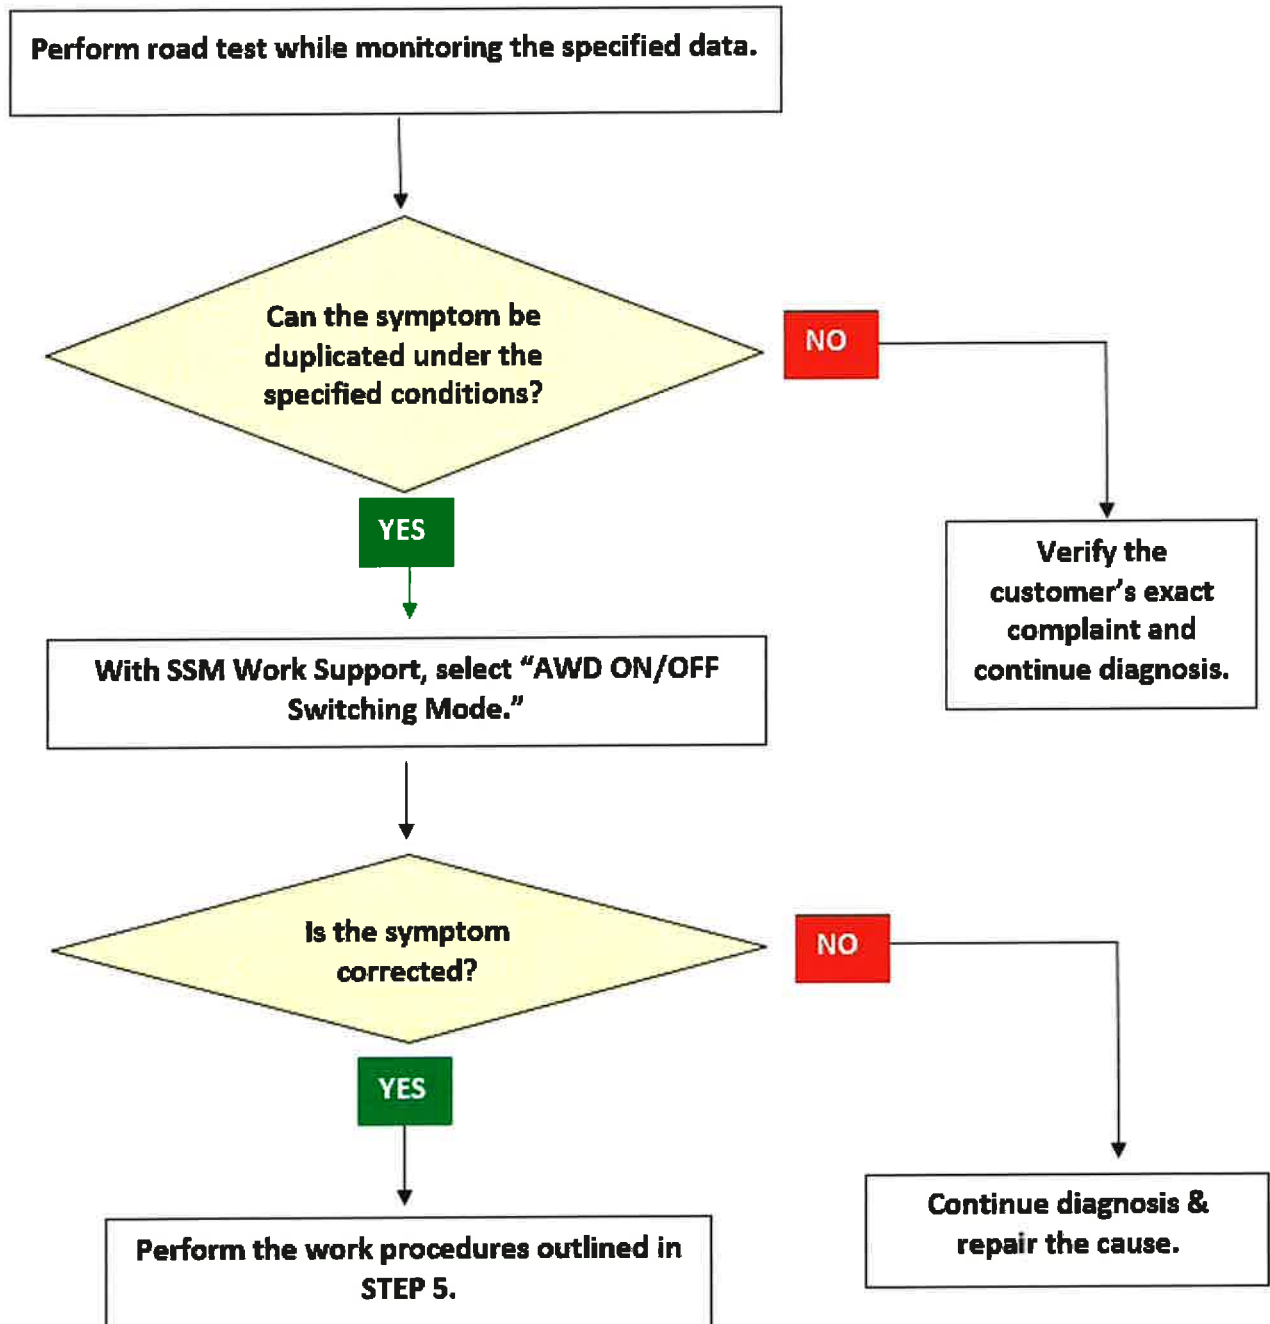
Procedure Overview Flowchart:

This service bulletin provides a temporary repair procedure to address vibrations and/or judder concerns experienced on turns during acceleration. If either of these conditions are verified, follow the confirmation process outlined below. If confirmed and until further notice, the multiple plate transfer (MPT) clutch will require replacement. A revised repair procedure will be introduced at a later date.

STEP 5: Replace **ALL** of the applicable parts outlined in the Part Information section of this bulletin.
